Inspection Report

Sample Report

Property Address:
1 Pleasant Ln
Manchester NH 03102

Advanced Home Inspection, LLC

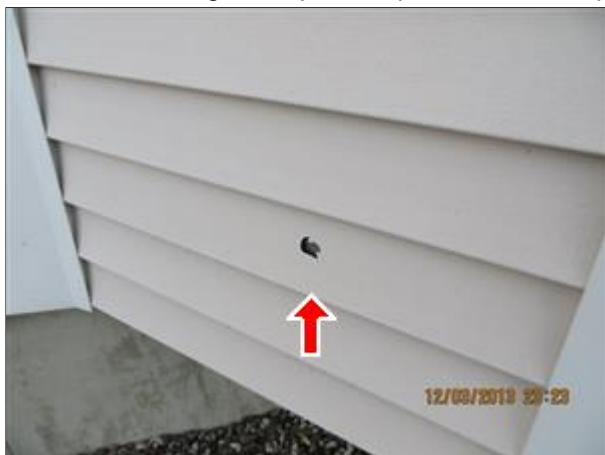
2.0 Picture 1

2.0 The vinyl siding on the left side gable (facing front) has several small holes and is pulling out of the J-channel at ground level. Water could penetrate through holes damaging structure if not corrected. There are also several areas where the aluminum trim is damaged. A qualified person should repair or replace as needed.

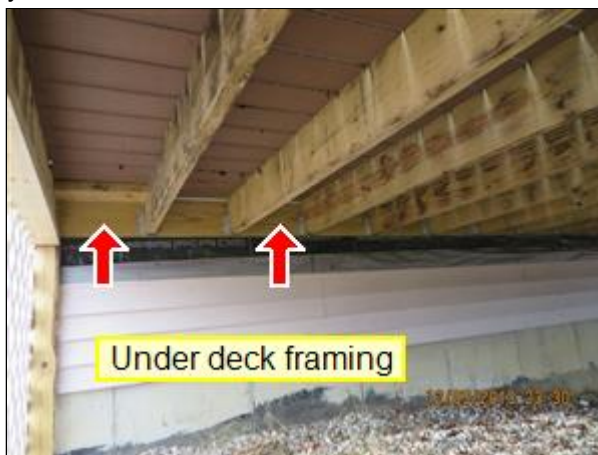
2.3 Picture 1

2.3 The deck band is not attached properly to the wall or band of the home. It should have 5/8 galvanized "Lag Screws" or "Carriage Bolts" approximately every 36 inches.

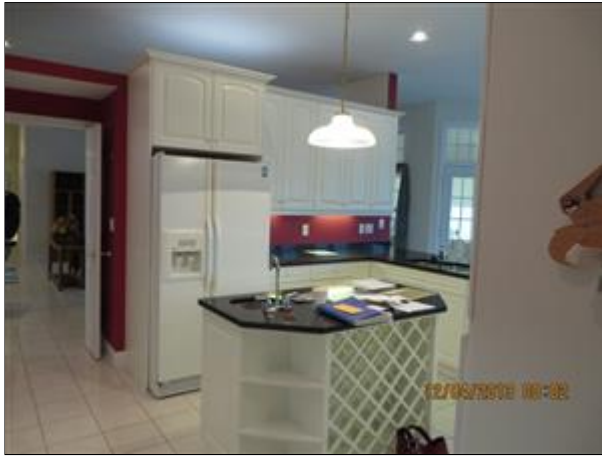
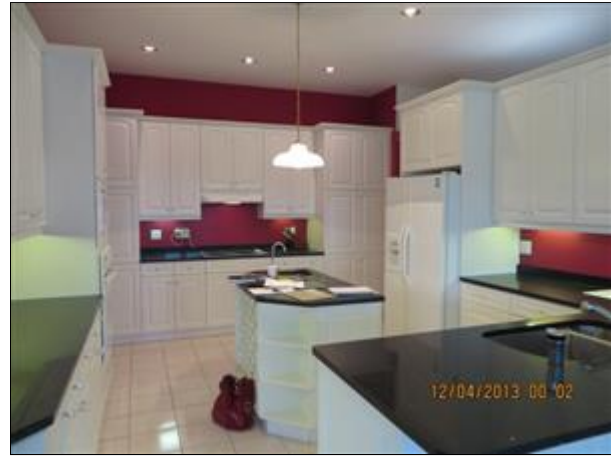
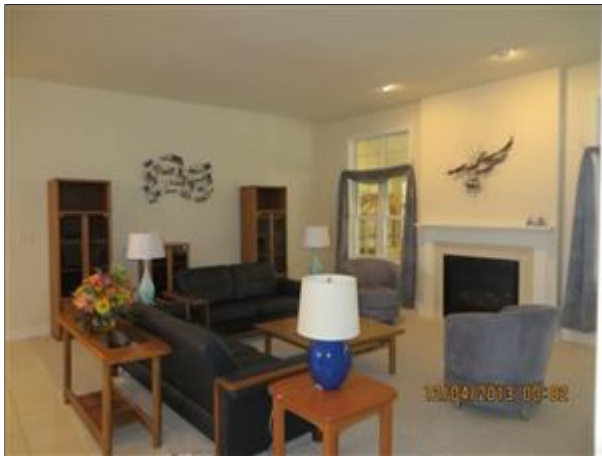
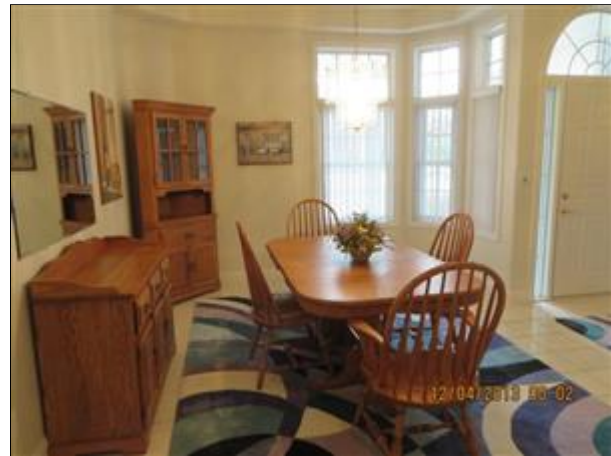
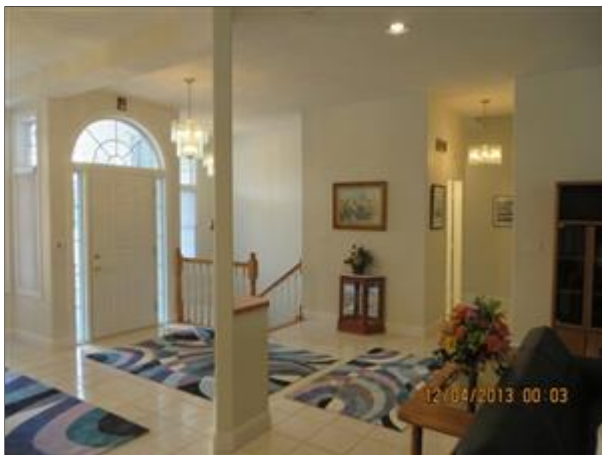
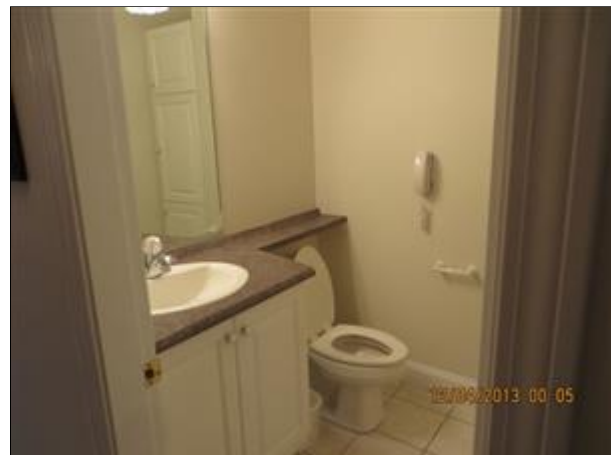
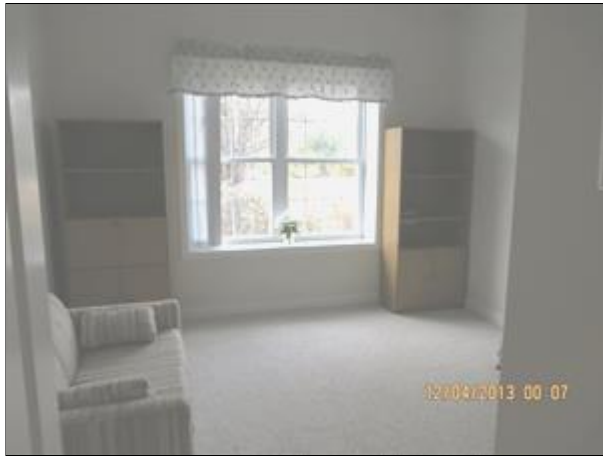
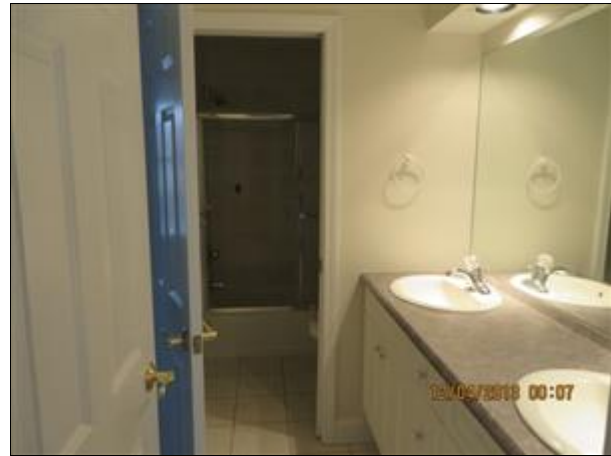
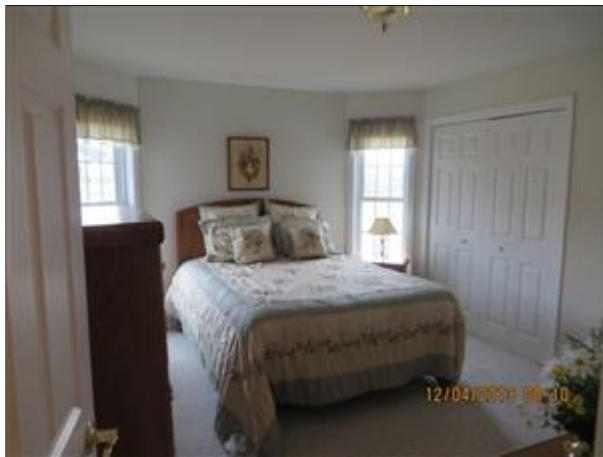
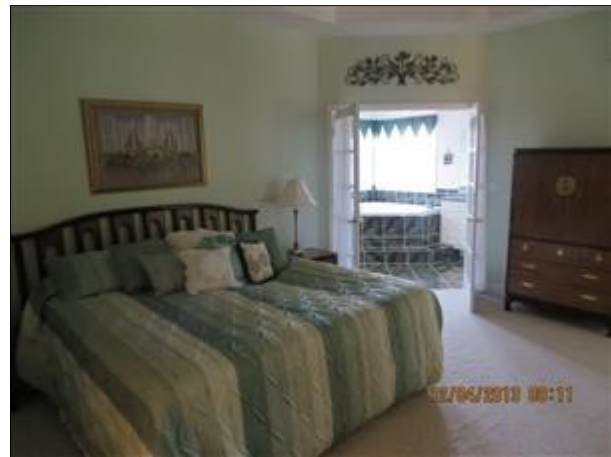
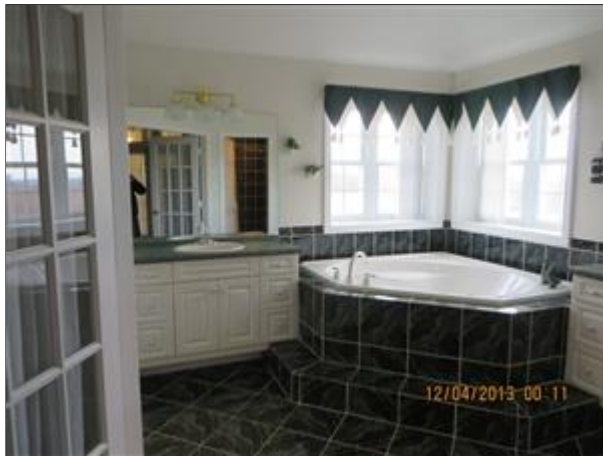
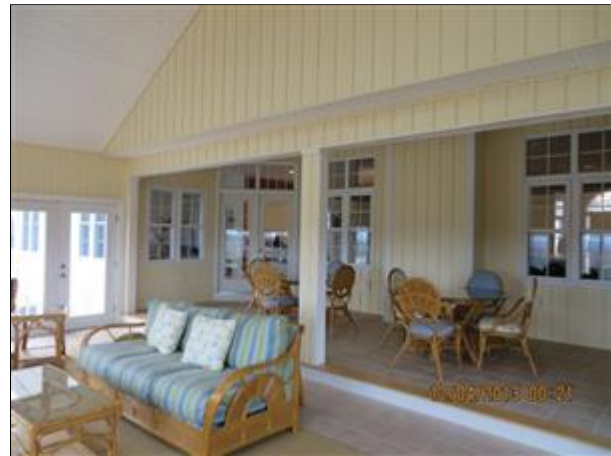
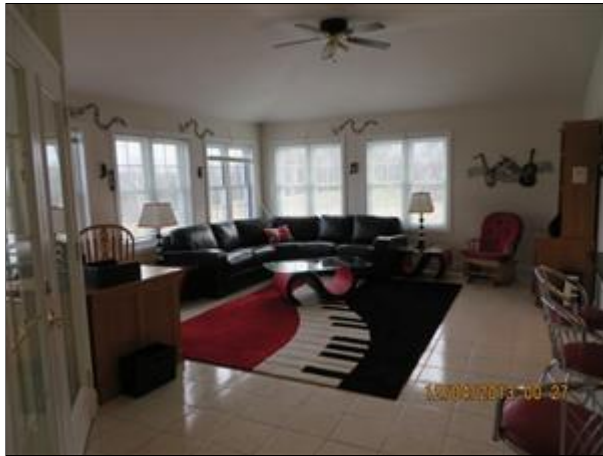
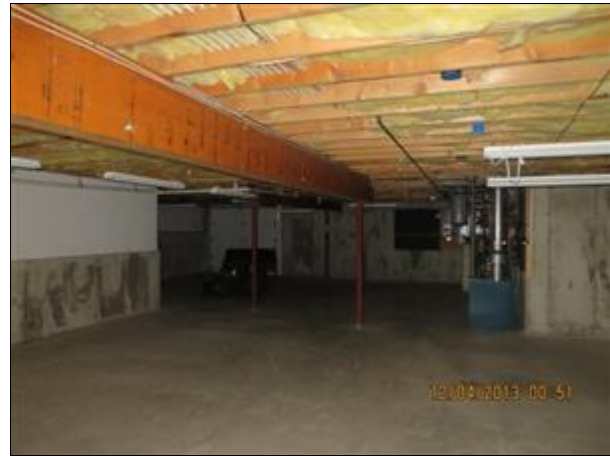
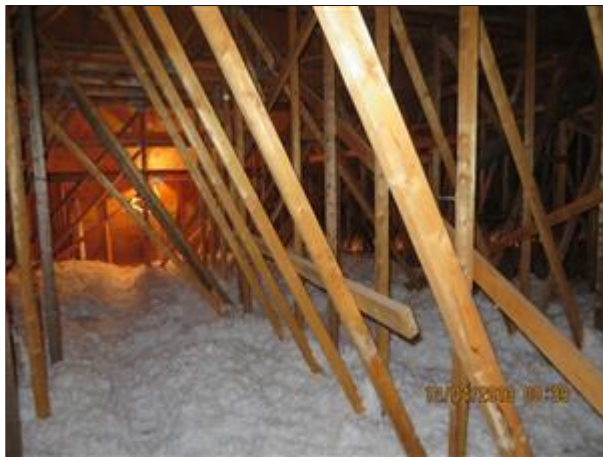
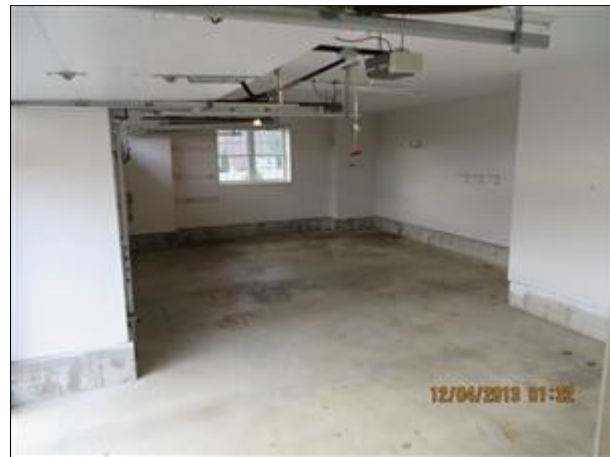
4.2 The tile is not properly supported from underneath at the kitchen due to missing bridging in the floor system. This damage is considered cosmetic. A qualified contractor should inspect and repair as needed.

4.3 The hand/guard rail for the stairs to basement missing handrail. A fall or injury could occur if not corrected. A qualified contractor should repair or replace as needed.

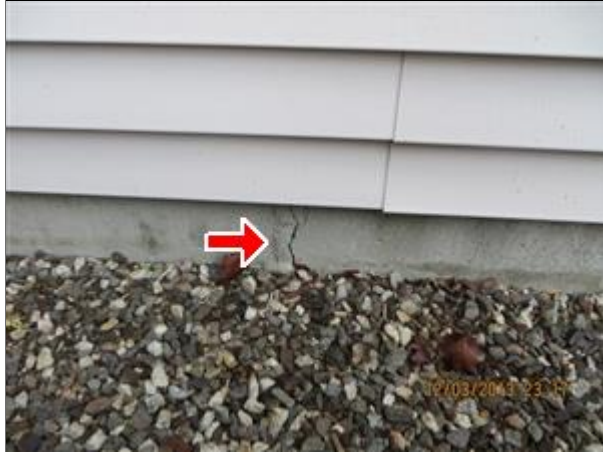
5.0 Picture 1

5.0 The foundation wall at the front of home and left side gable (facing front) of house has several small cracks. These cracks do not appear significant to require repairs at this time.

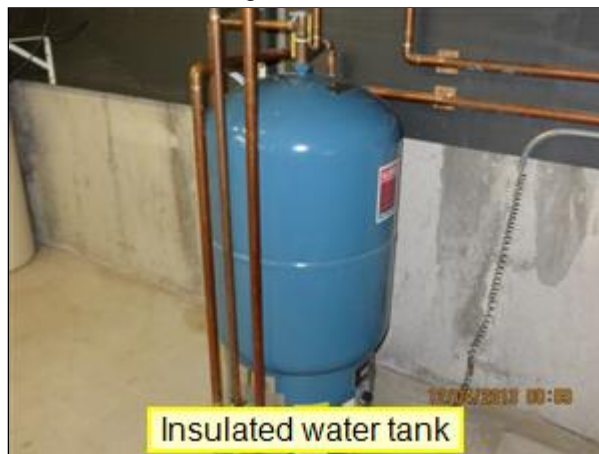
6.2 Picture 1

6.2 Hot water is supplied by boiler in the insulated storage tank.

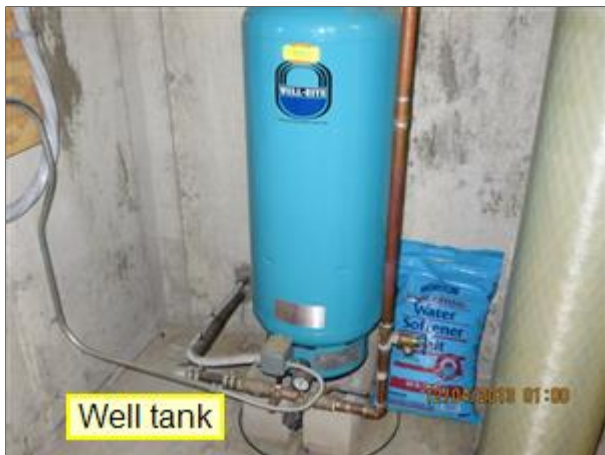
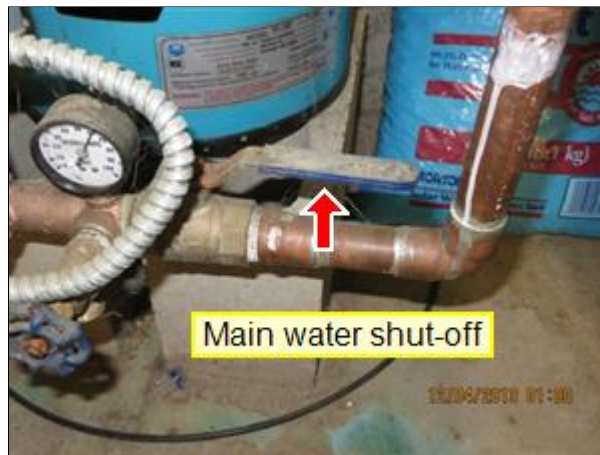
6.3 The main shut off is the blue lever at the well tank located in the basement. This is for your information.

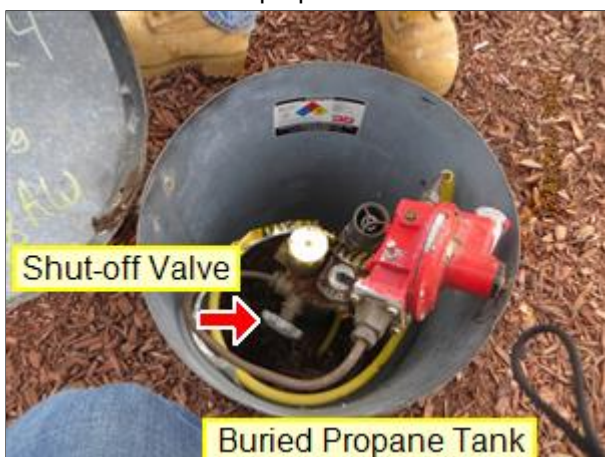
6.5 The main fuel shut off is at propane tank outside. Secondary shut-off located at the regulator on the side of the house.

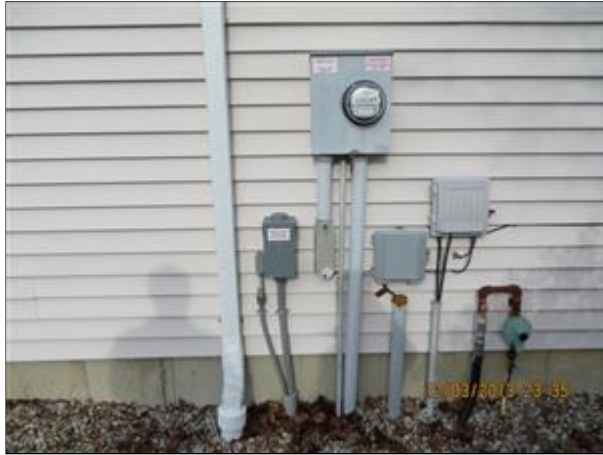
Service meter

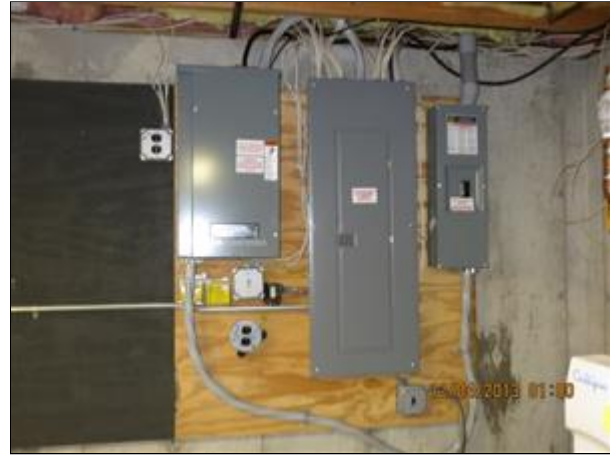
Main electrical panel

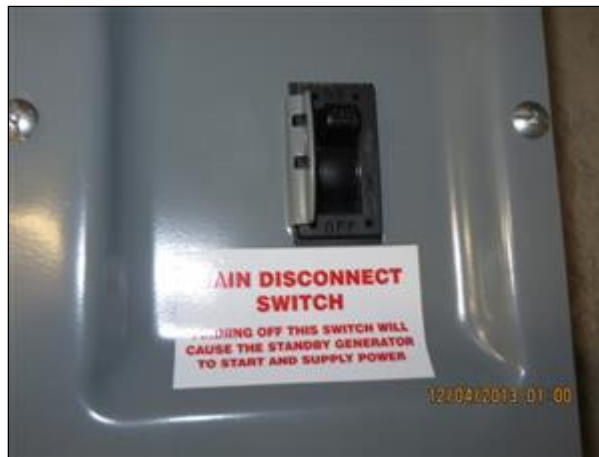
7.1 Picture 1

7.1 The main electrical disconnect located next to the main electrical panel in basement.

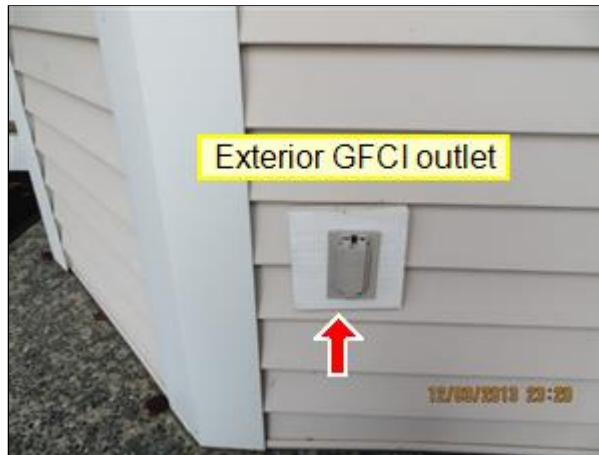
7.3 Picture 1

7.3 At least One GFCI (Ground Fault Circuit Interrupter) outlet at the main entry loose in the wall, and needs to be secured properly. Electrical issues are considered a hazard until repaired. A qualified licensed electrical contractor should perform repairs that involve wiring.

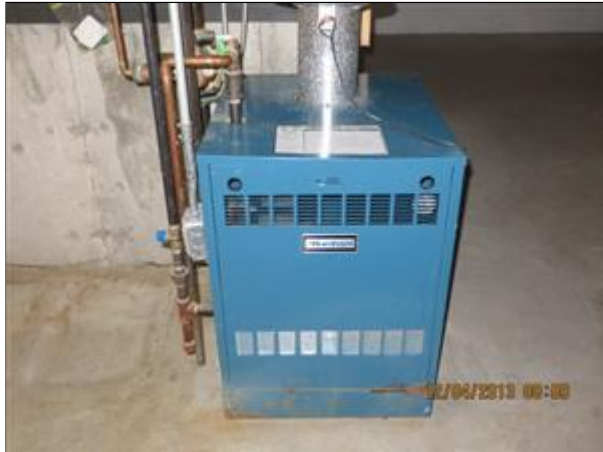
Propane gas FHW boiler

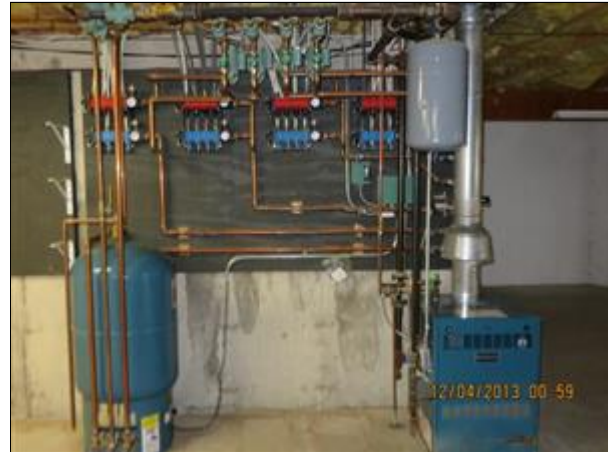
Radiant heating system

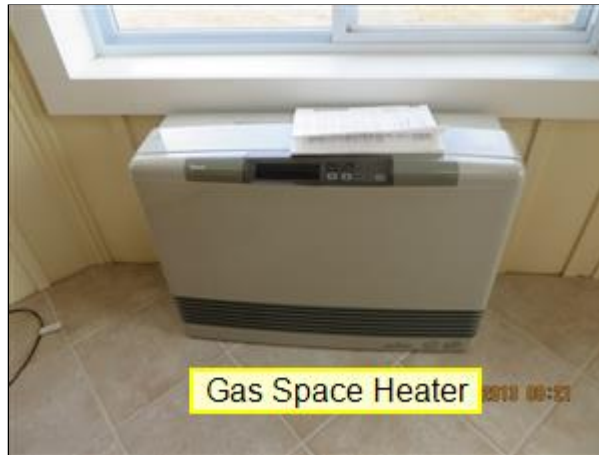
8.4 Picture 1

8.4 Propane gas space heater not active at the time of inspection and was not inspected.

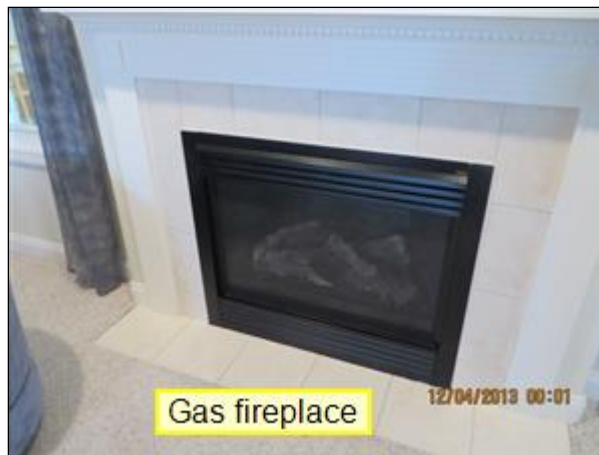
8.7 Picture 1

8.7 Did not inspect because unit was offline at the time. Recommend qualified contractor service gas fireplace and space heater before continued use.

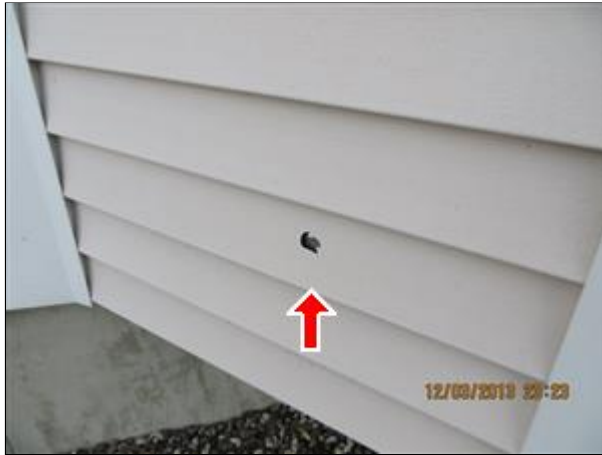
2.0 Picture 1

The vinyl siding on the left side gable (facing front) has several small holes and is pulling out of the J-channel at ground level. Water could penetrate through holes damaging structure if not corrected. There are also several areas where the aluminum trim is damaged. A qualified person should repair or replace as needed.

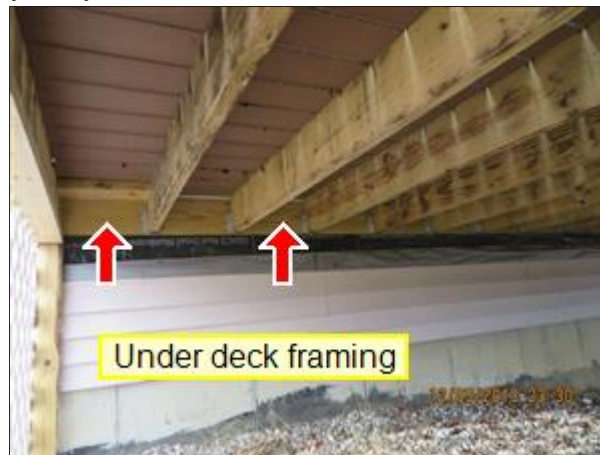
2.3 Picture 1

The deck band is not attached properly to the wall or band of the home. It should have 5/8 galvanized "Lag Screws" or "Carriage Bolts" approximately every 36 inches.

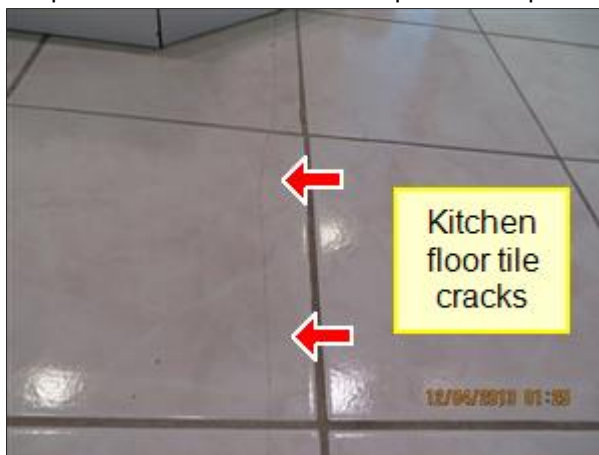
4.2 Picture 1

The tile is not properly supported from underneath at the kitchen due to missing bridging in the floor system. This damage is considered cosmetic. A qualified contractor should inspect and repair as needed.
